**Flood Control Project Maintenance
Levee Inspections**

Maintenance Issue Types Only, Levee Inspection Report By Mile - Fall 2016

Reclamation District No. 2063 Crows Landing

Waterway	Bank	Unit Miles	Inspection Start/End	Inspector
Unit No. 01 San Joaquin River	Right	10.44	10/25/2016 10/25/2016	Richard Willoughby

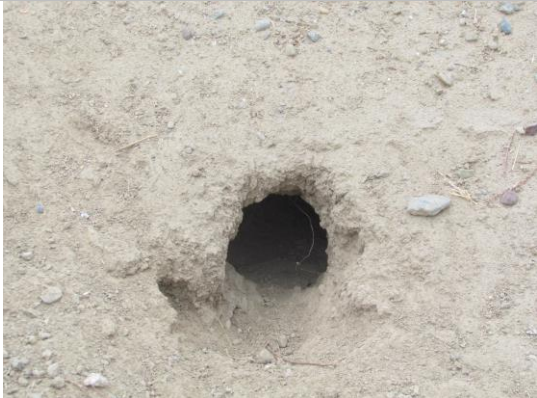
Photo 2 of 2 : FA_2016_RD2063_112_11_20161027_00083.jpg

Looking at close-up view of rodent hole on landward slope.

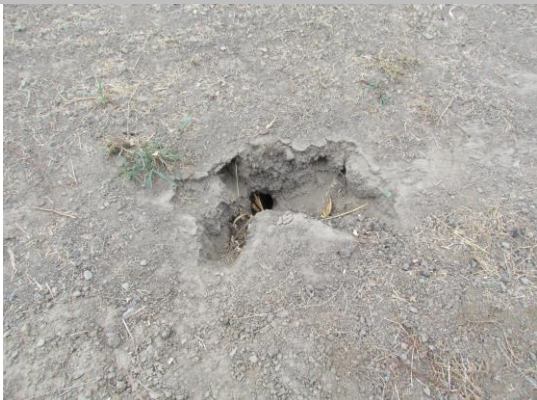
Photo 1 of 2 : FA_2016_RD2063_112_46_20161027_00086.jpg

Looking at large rodent hole on landward slope.

LM Start	2.01	Rating **	U	Issue No.	46 (cont)	
LM End	2.01	Issue Type +	Ma	Location *	LS	
Category	Earthen Levee			GPS Latitude/Longitude		
				Start	End	
Item	Animal Control			37.455136 °	37.455136 °	
				-121.032912 °	-121.032912 °	
DWR ID	DWR_RD2063_01_f _ 2016_46					
Comment Code						
A3 : No rodents visible, but rodent burrows visible; need to backfill and compact or grout burrows.						
Inspector Comment						
Three large rodent holes on landward slope.

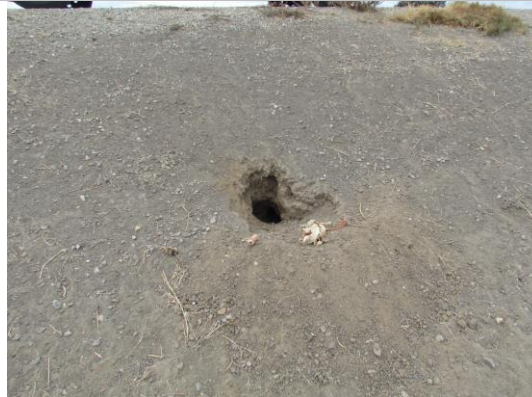
Photo 2 of 3 : FA_2016_RD2063_112_47_20161027_00088.jpg

LM Start	2.34	Rating **	U	Issue No.	47 (cont)
LM End	2.37	Issue Type +	Ma	Location *	LS
Category	Earthen Levee			GPS Latitude/Longitude	
				Start	End
Item	Animal Control			37.451394 °	37.451064 °
				-121.029426 °	-121.029072 °
DWR ID	DWR_RD2063_01_f_2016_47				
Comment Code					
A3 : No rodents visible, but rodent burrows visible; need to backfill and compact or grout burrows.					
Inspector Comment					
Large rodent holes on landward slope.

Looking west at rodent hole on landward slope.

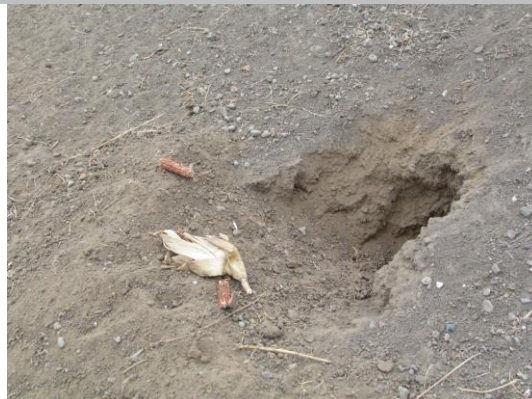
Photo 3 of 3 : FA_2016_RD2063_112_47_20161027_00090.jpg

Looking northwest at rodent hole on landward slope.

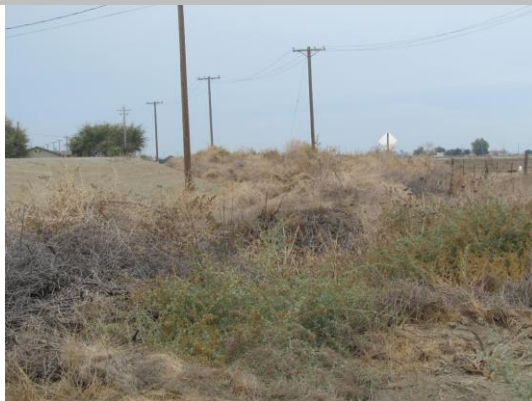
Photo 1 of 2 : FA_2016_RD2063_112_2_20161027_00093.jpg

LM Start	3.89	Rating **	U	Issue No.	2
LM End	3.97	Issue Type +	Ma	Location *	LS
Category	Earthen Levee			GPS Latitude/Longitude	
				Start	End
Item	Vegetation			37.434506°	37.433441°
				-121.014394°	-121.013633°
DWR ID	DWR_RD2063_01_s_2016_2				
Comment Code					
V2 : Remove the wild growth other than native grasses from the levee slopes.					
Inspector Comment					
Remove dense veg on landward berm.

Looking north at dense veg at landward toe and berm.

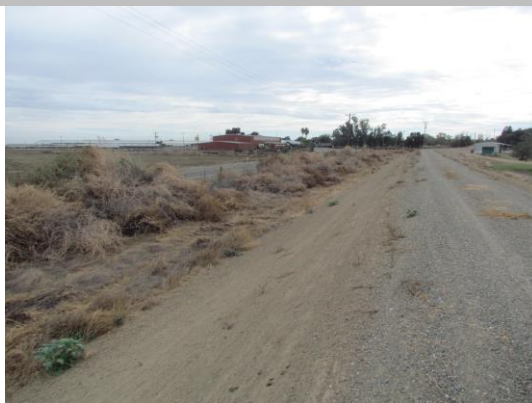
Photo 2 of 2 : FA_2016_RD2063_112_2_20161027_00092.jpg

Looking south at dense veg at landward toe and berm.
